# DENNIS BURGESS MARINE SURVEYS

This **Pre Purchase Condition & Valuation Survey** was performed upon the request of the possible buyer. The purpose of this survey was to confirm the condition, value and seaworthiness of the vessel.

Builder: Formula Boats

Model: 370 SS

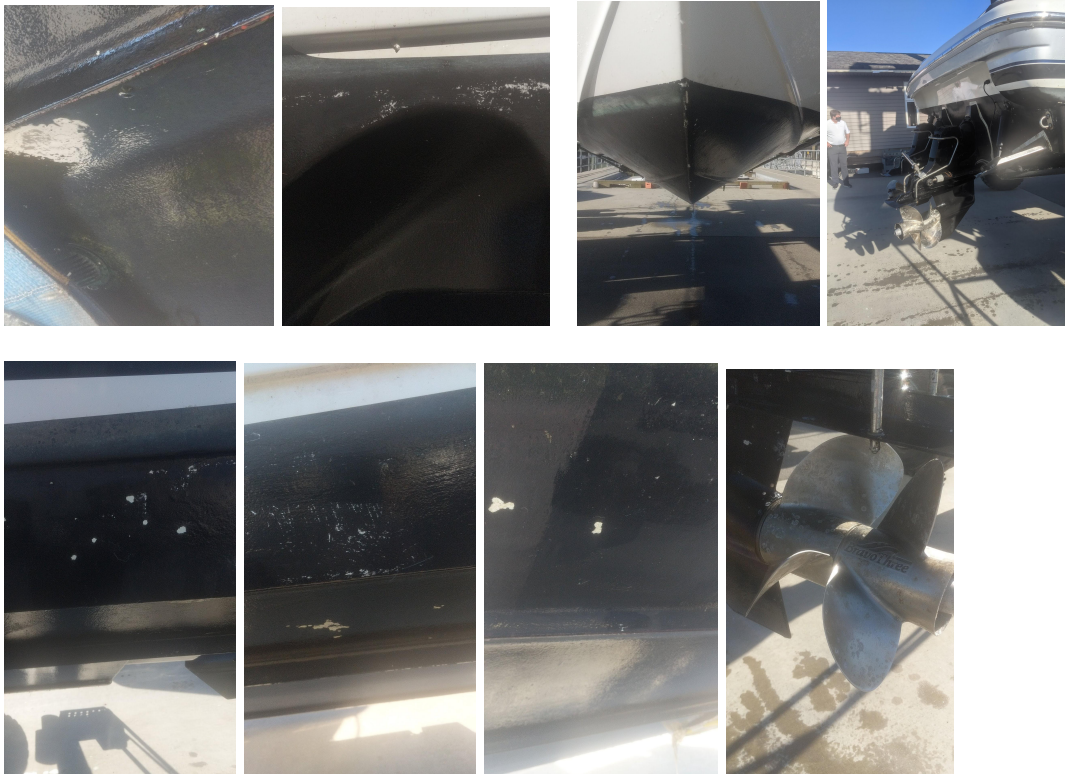
Moulded fiberglass hull. The hull was in extremely good condition for a boat of this age. There were a few scratches and minor gouges that are expected with a boat this age just from regular wear and tear. The underwater portion of the hull was covered with a black antifouling paint. The paint was old and needs to be sanded down and repainted. The hull had almost no growth. There was many areas with chipping or no paint at all on the hull. The complete hull and transom were checked with a moisture meter and hammer tested. The hammer testing and moisture readings in the transom area did not show any signs of rot or deterioration and seemed solid. There were no signs of impacts or recent damage to the hull.

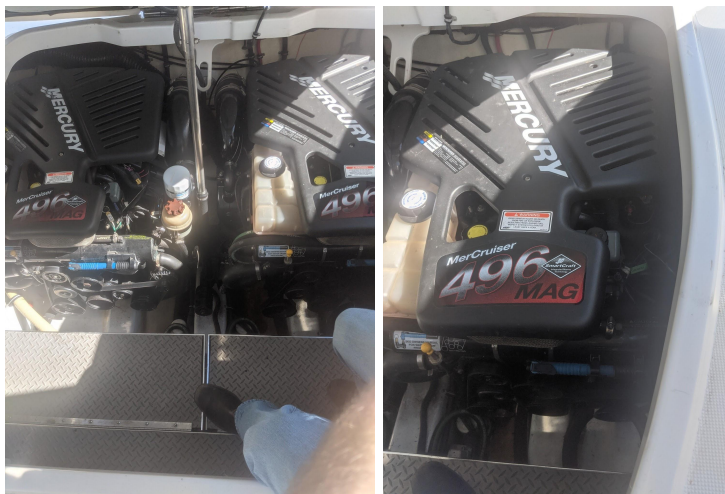
On April 14, the vessel was taxied slowly from the haul out platform to her slip. The engines ran smoothly with no signs of smoke or misfire. The engines were visually inspected for any defects, none were found. Both engines have new Manifolds and Risers. The engine compartment was clean but the bilge under the engines had a small amount of water. The engines were also quite clean and appeared to be well cared for. Wiring was bundled and kept clear of any snags or hot areas. All hoses and connections were in near new condition and most of the connections had double stainless steel hose clamps. For safety reasons any hose connected to a thru hull above or below the waterline should have double clamps. The batteries were placed in the engine compartment with approved tie downs but they were not in approved battery boxes with proper covers to avoid any short circuits, fire or battery failure.

1. No flares on board. Flare shelf life is typically 42 months after date of manufacturing (3 ½ years) in accordance with the Coast Guard requirements. New flares should be purchased prior to any navigation of the vessel.
2. Vessel requires proper battery covers to prevent any battery failure, short circuit or fire.
3. The vessel has one fire extinguisher inside the cabin. Another fire extinguisher is needed in the outside area near the engines.
4. For safety reasons any hose connected to a thru hull must have double stainless steel hose clamps on both ends.

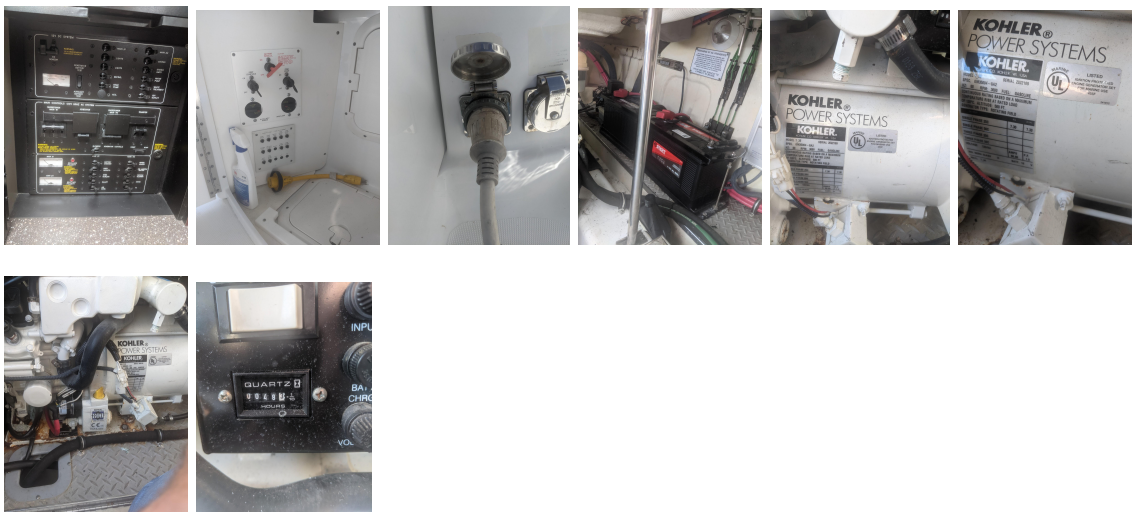
All wiring is in very good condition and approved for marine use. The electrical panel installation is original and in good condition. The shore power cord was in good condition with no signs of overheating or bad connections. The vessel also has a near new Kohler generator with only 48 hours of runtime.

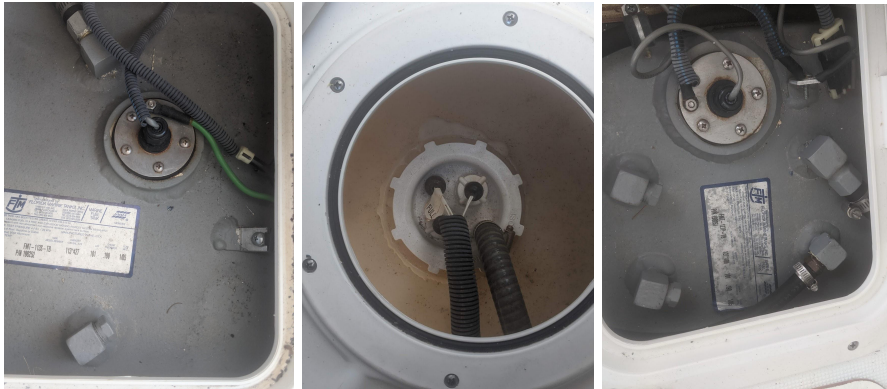
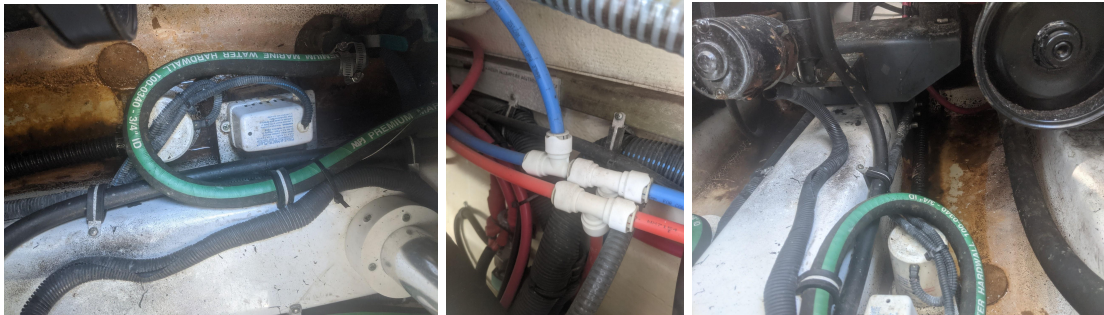
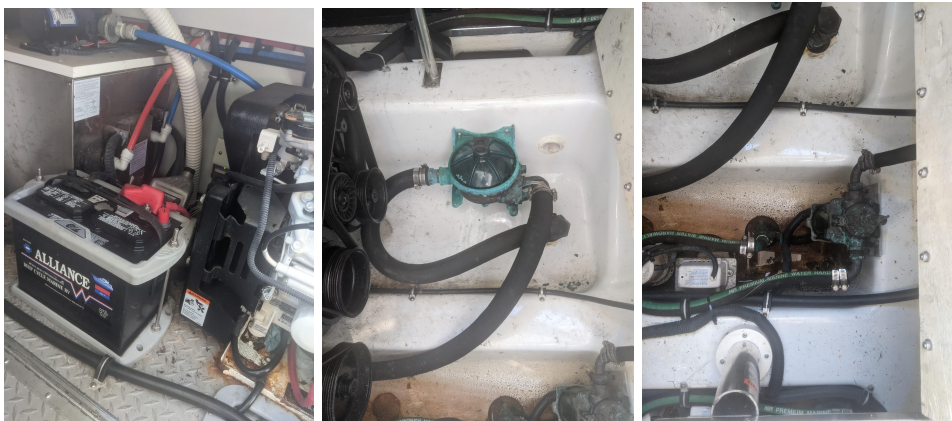
All Tanks were in very good condition. Each tank had its own shut off valve. All hoses were in good condition and most were double clamped. All through hulls were in good condition with their own shut off valve. All valves closed and opened easily with no leaks or stiffness. All bilges were clean and dry except for under the engine where there was a small amount of rain water.

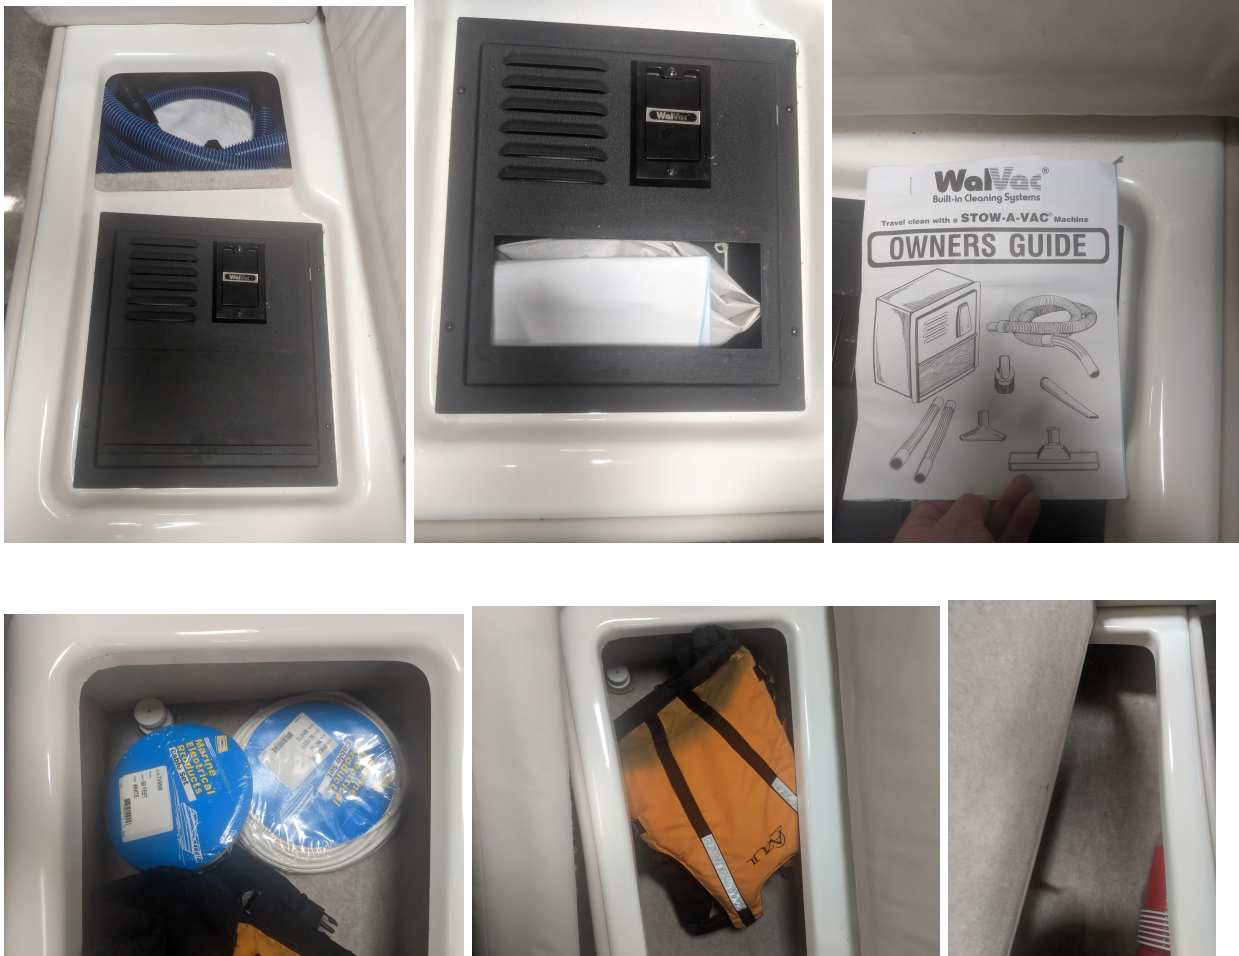
Some Interior bulkheads were used for extra storage. Under the bench seat on the starboard side there was a built in vacuum system that was tested and worked properly. All compartments were clean and showed no signs of delamination or rot. Very good condition for a vessel of this age.

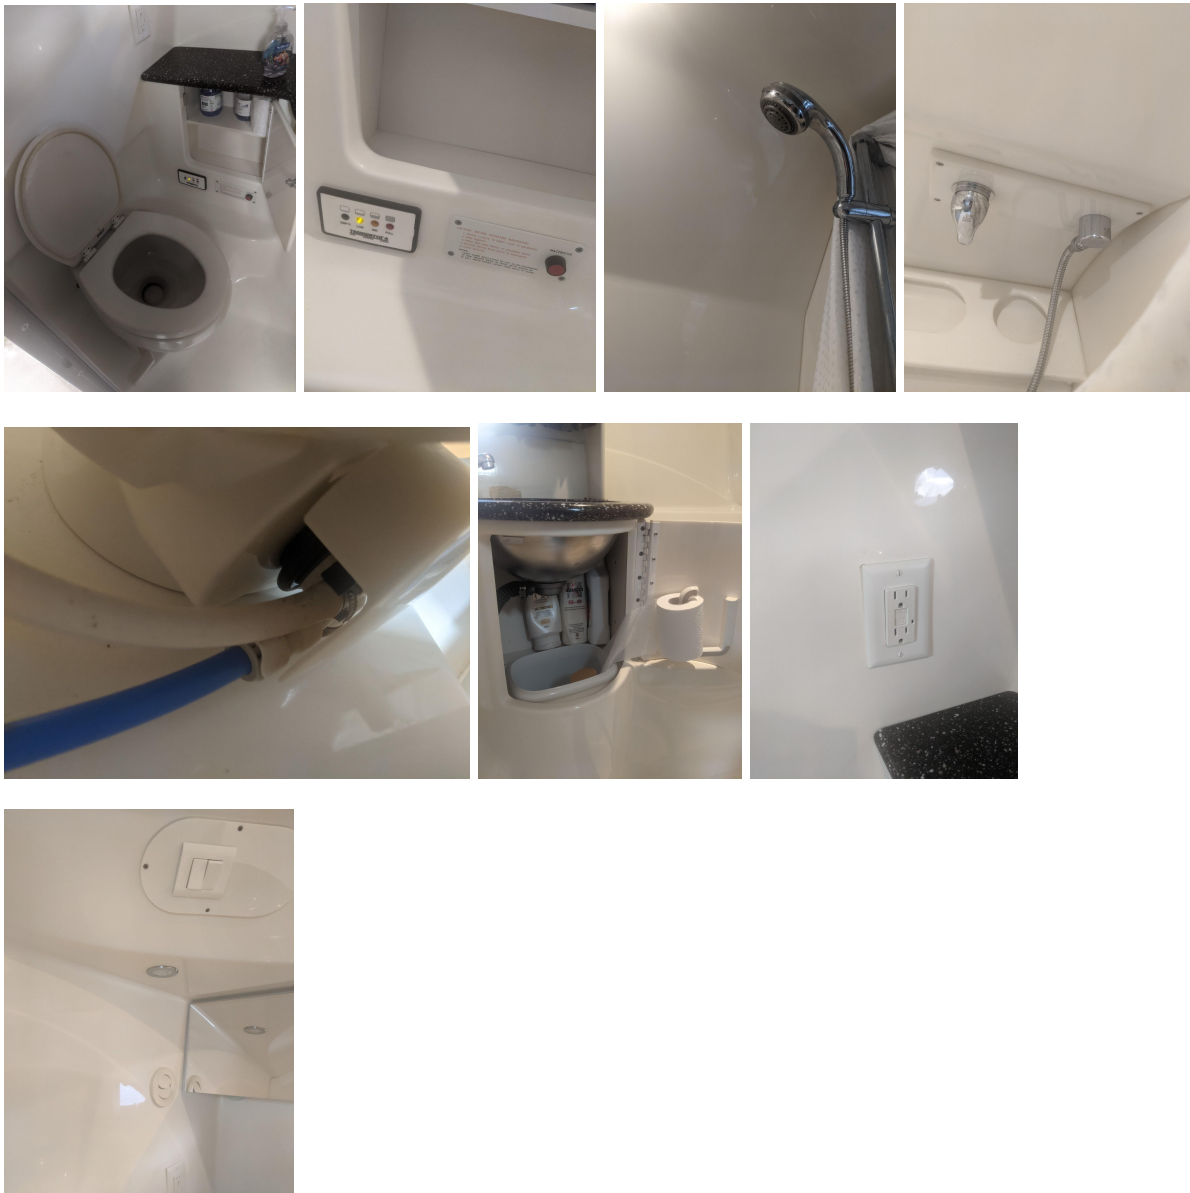
Toilet and Shower system. The hose to and from the toilet needs proper double stainless steel clamps. The automatic push button toilet system was tested and flushed properly. The shower system can be stationary or hand held with hot & cold water. There is a shower curtain to separate the shower area from the toilet. The head is equipped with proper GFI plugs, a built in fan and 2 lights. The light above the toilet is out.

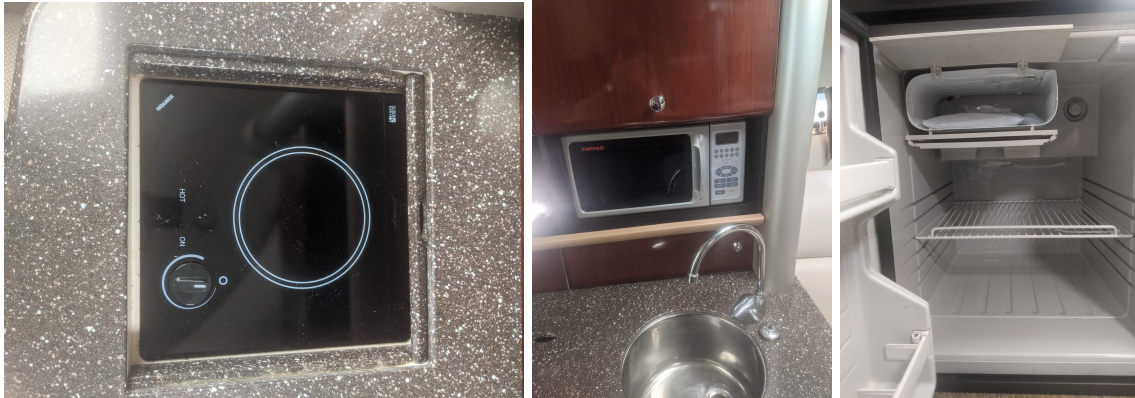
The Galley area had an Electric Fridge, Microwave, stove top and sink. All of the galley equipment were clean and in good condition at the time of the survey. The galley equipment was tested and all worked properly.

1. The existing fire extinguisher should be inspected by an authorized technician.
2. Sacrificial zincs on the legs should be replaced with new.
3. The hydraulic hinges on the cupboard doors in the galley do not work properly and should be replaced.
4. Port & starboard engines are both about 1 litre of oil low and should be topped up.
5. Starboard engine is low on drive lube.
6. Light in the stern bunk is out.
7. Light in the stern bunk entrance is out.
8. Light in the bathroom is out.
9. The mosquito mesh on the stern panel of the enclosure is torn in a few places and needs to be replaced.
10. The batteries in the remote for the TV have leaked and damaged the control. The remote does not work. Battery area needs to be cleaned and new batteries installed.

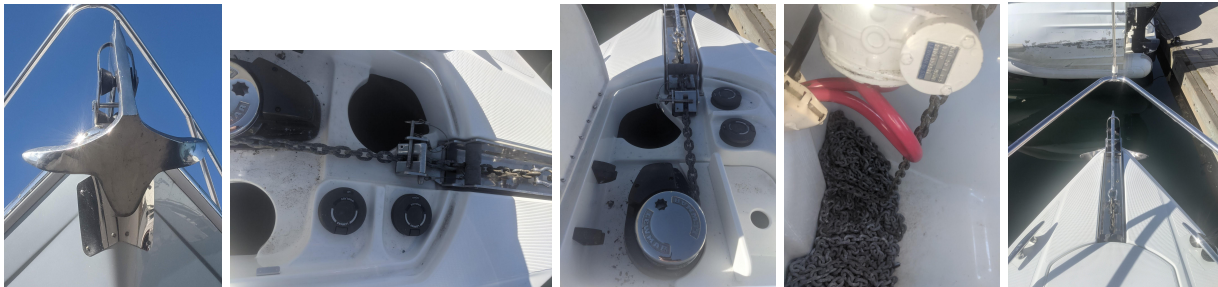
Anchor and chain were clean and in good condition. There was some minor rust on some portions of the chain but nothing that would question the structural integrity of the chain. All areas were clean and tidy. Windlass powered up ok but was not operated so I cannot comment on it's performance.

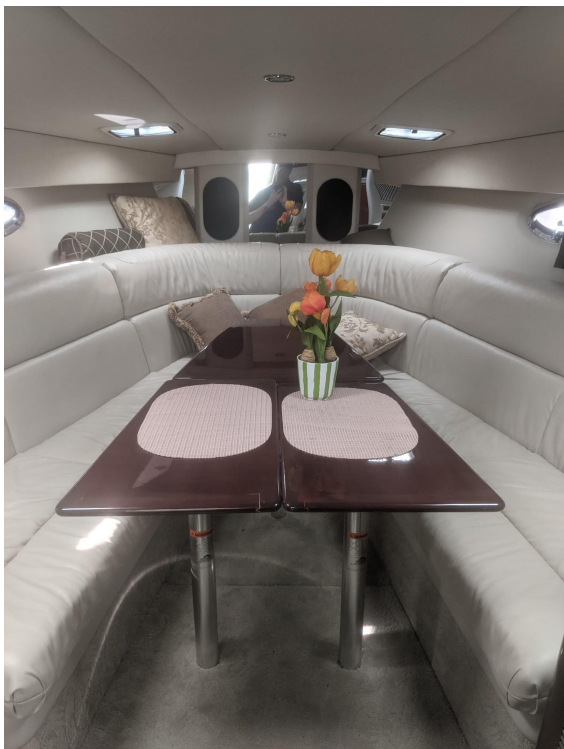
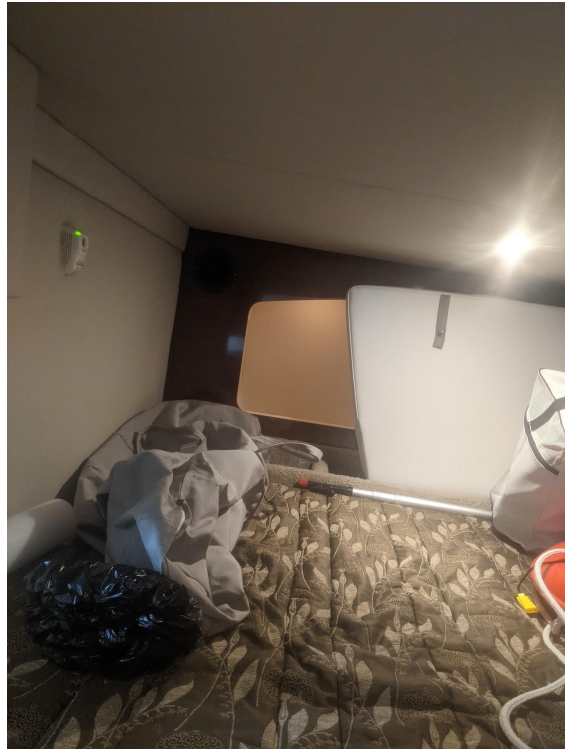
The inside cabin area was quite spacious for a vessel of this size and allows 4 to 6 people to enjoy the boat quite comfortably. The table can be lowered to create another nice sleeping area. All windows and the hatch were checked. The hatches opened with ease and closed, forming a good seal with no leaks. There were no signs of any leaks or moisture ingress into the cabin from the windows. The inside of the vessel was dry and in good condition. All upholstery was in very good condition. The cabin is quite bright and airy when all the hatches are opened and windows are exposed. The vessel has 2 main sleeping areas. One in the cabin and the other is in the stern. Both areas can sleep 2 adults comfortably. One light in the stern berth and one light in the entrance to the berth were out. The heating /air conditioning system was run for 15 minutes and worked properly. The stereo was tested and worked fine.

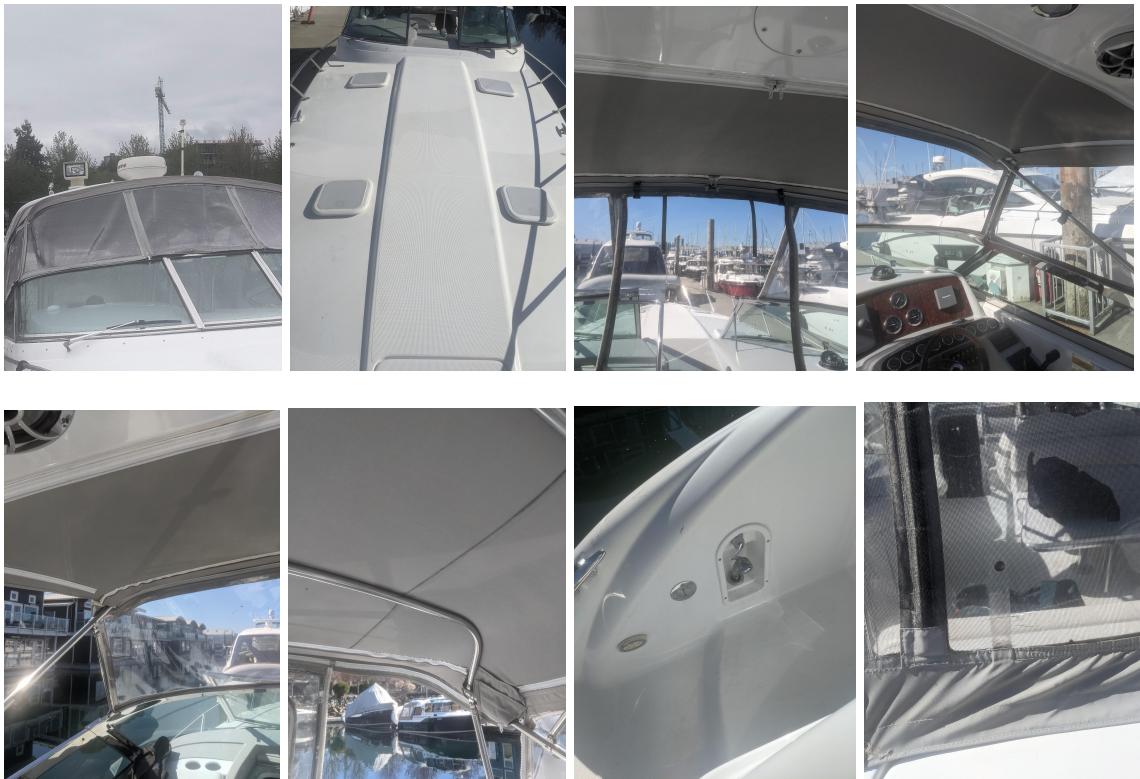
The outside area of the vessel is all open but the cockpit area has a canvas cover that can be easily put up or down when needed. The bow was accessible by stepping up past the steering console and going through the middle window that swings open. The stern of the vessel was open with enough room for fishing or just sitting and lounging outside. All areas of the deck were hammer tested and all areas were solid with no voids. There were no signs of any stress cracks to be found. The canvas top was in good condition except for the stern mesh that covers the back window was torn in a few places and needs to be replaced. There is also an outside hand held shower in the stern entrance near the swim grid.

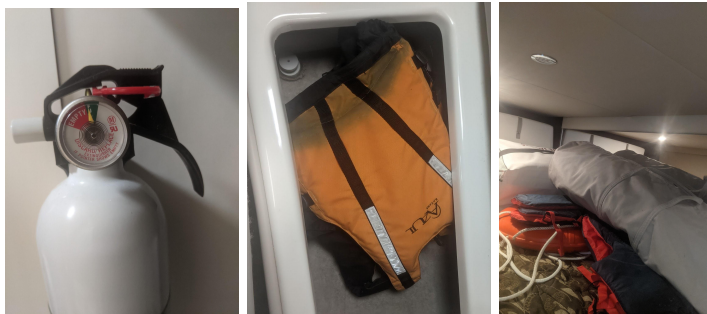
Fire Extinguisher	1 charged and ready for use
Life Jackets	8 on board, adult size in good condition
Throwable Devices	one found in stern cabin
Flares	none found
Paddles	2
Bilge Pumps	3 pumps
Sound signalling device	Vessel has a built in horn (tested ok)
VHF radio	Located next to the steering console
Tender / Liferaft	N/A
Anchors	1 Bruce Anchor / Claw or Scoop
CO2 Detector	2 (tested ok)
Spare Propellers	none on board
